INTERSTATE COMMERCE COMMISSION

REPORT OF THE CHIEF OF THE DIVISION OF SAFETY COVERING THE INVESTIGATION OF AN ACCIDENT ON THE BALTIMORE & OHIO SOUTHWESTERN RAILROAD AT ORIENT, OHIO, ON AUGUST 12, 1915

OCTOBER 12, 1915

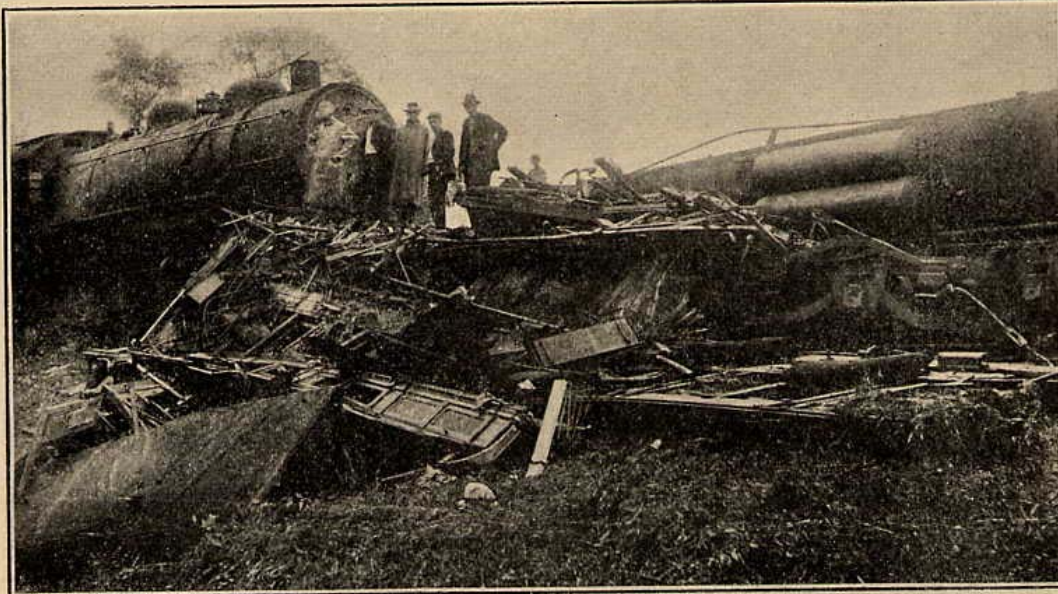
The locomotive of train 199 demolished the rear coach of extra 1474. This car was burned at the scene of the accident. The second rear car in the train was a wide vestibule car, and its east end was crushed in for a distance of about 10 feet and the car turned over on its left side. The third car had one corner post broken. The front end of engine 2669 was slightly damaged. Illustration No. 1 shows the demolished rear coach and the second rear coach turned on its left side Illustration No. 2 is a view of the damaged end of the second rear coach after it had been righted and placed upon its trucks.

No. 1.—View showing demolished rear car, with the car next to the rear turned on its left side.

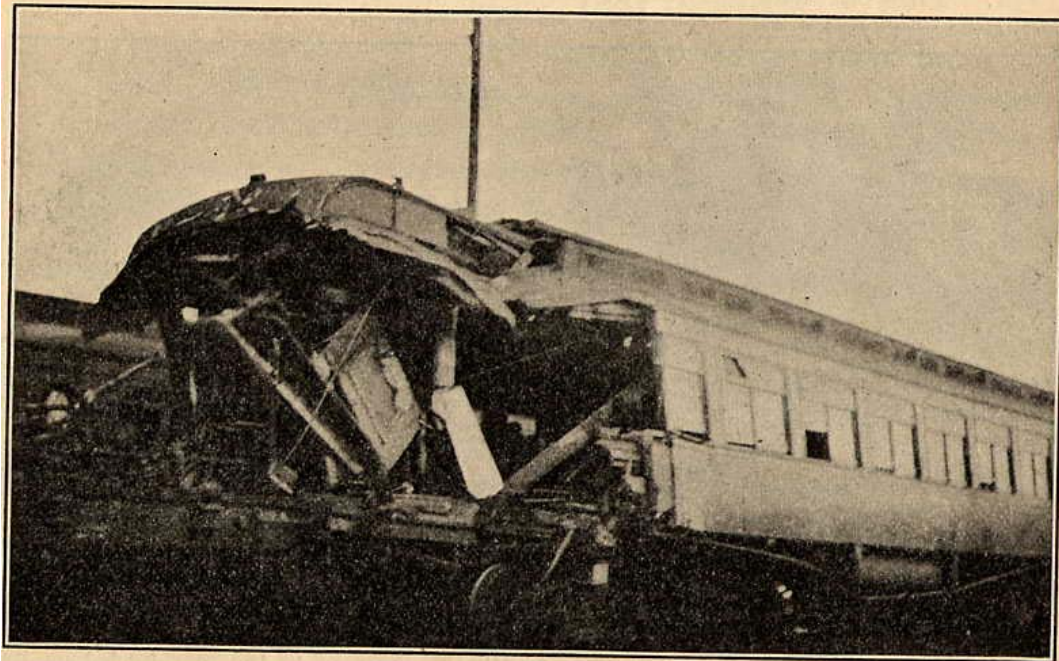
No. 2.—Damaged end of the car next to the rear.

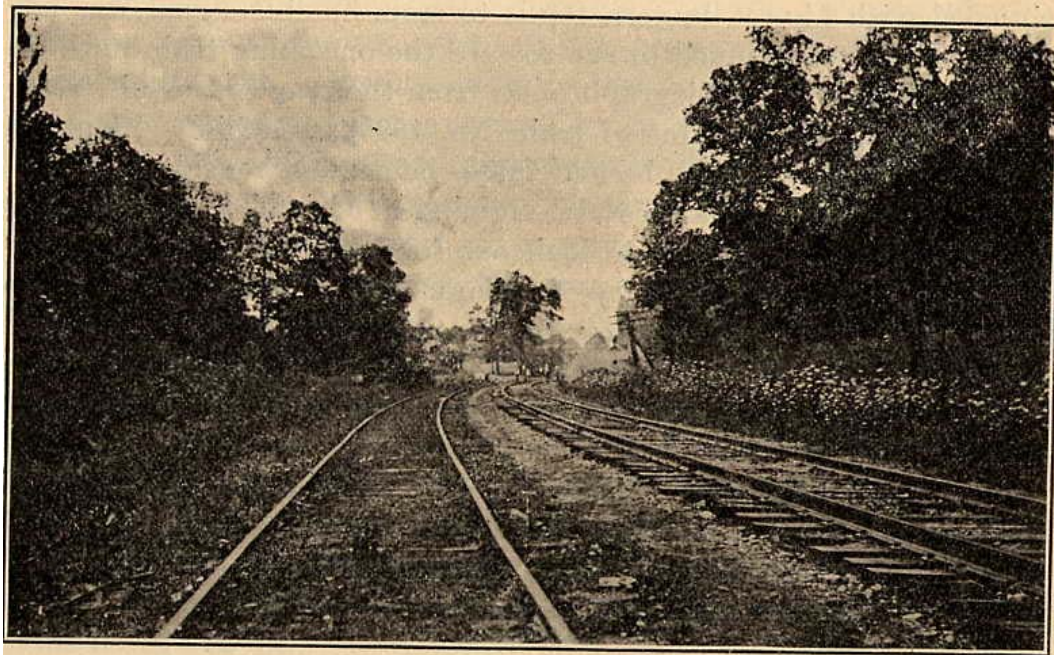
Beginning at a point about 07 of a mile east of Orient station and proceeding westward the track is tangent for about 850 feet. This is followed by a 2 degree curve to the right 2,700 feet in length, followed in turn by a 1 degree 14' curve to the right 1,200 feet in length. It was 2,300 feet west of the east end of the first mentioned curve that the accident occurred: A view of about 750 feet may be obtained from the engine of an approaching west bound train. At this point there is a grade of 05 per cent descending westward Illustration No. 3 shows the view approaching the point of accident from the east.

No. 3.—View approaching point of accident from the east.
