General Report No. 1786.

Individual Report No. 4.

Risk: Car Houses.

Location: W. Broad St. and Glenwood Ave, Columbus, Ohio.

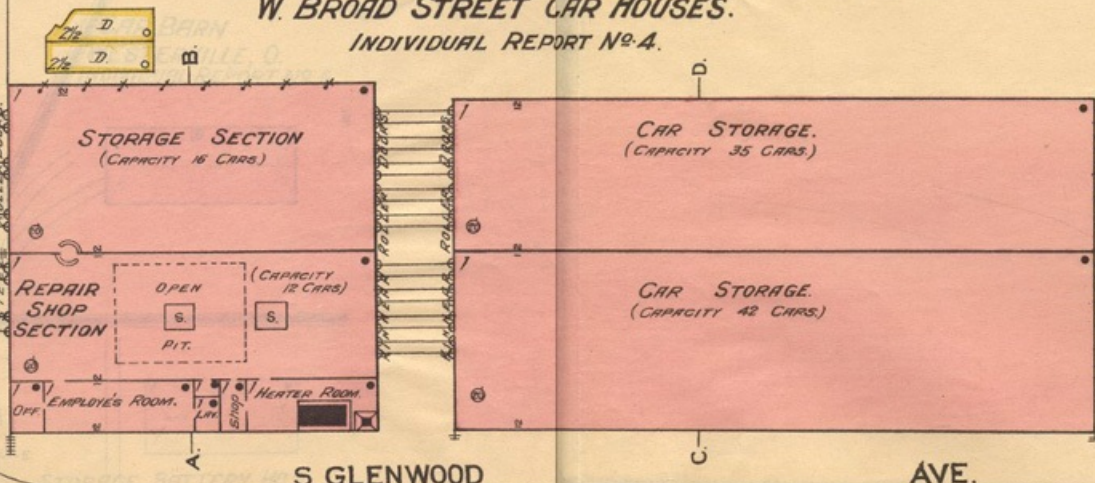
MAP NO. 5.
OHIO INSPECTION BUREAU
T. B. SELLERS, MANAGER.
COLUMBUS, OHIO.
MARCH, 1909.
SCALE 1" = 50' N.P.M.

Some oils are stored in the risk, car wiring is not nearly standard and trolley poles are not drawn down out of contact during the storage of cars.

1. Remove car oil now stored in the risk to an outside location not exposing.
2. Make car wiring standard and remove trolley poles from contact with trolley wire during the storage of cars.
