General Report No. 1786.

Risk: Car Houses.

Location: Cleveland Ave., Milo, Ohio.

Owner and Occupant: The Columbus Railway & Light Co.

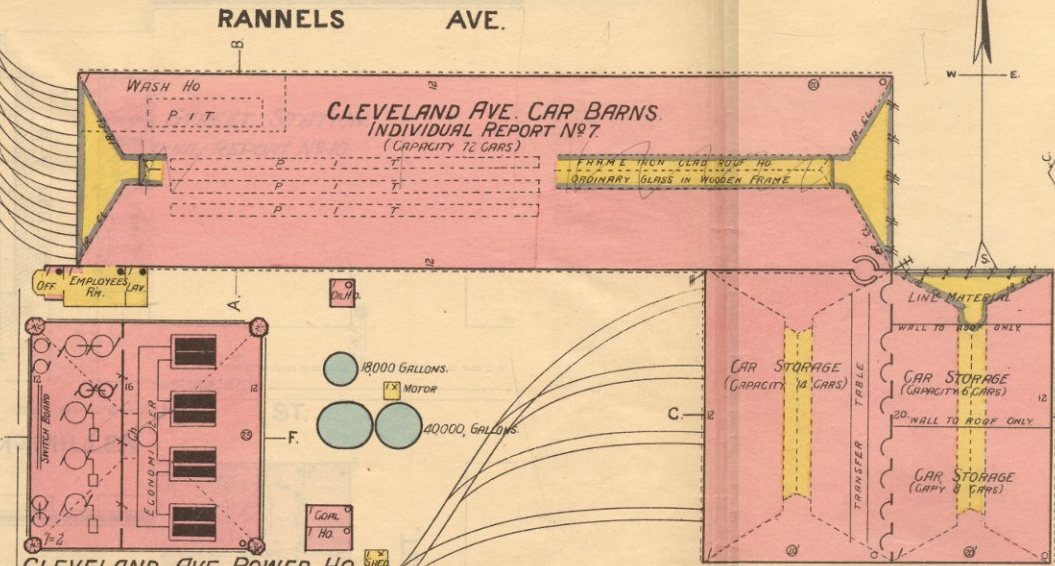
MAP No. 6.
OHIO INSPECTION BUREAU
T. B. SELLERS, MANAGER
COLUMBUS, OHIO.
MARCH 1909.
Scale 1"=50' H.R.M.

SECTION - A - B.
D - 12" WALLS PILASTERED 8" X 8" 15' CENTER
OF TRUSSES. ROOF TRUSSING SUPPORTED BY METAL TRUSSES
SET ON METAL POSTS BRACED INTO WALLS.
C - FRAME METAL CLAD ROOF LANTERN WITH WOODEN FRAMED WINDOWS
AND ORDINARY GLASS.
E - PIT WITH CONCRETE SIDE AND BOTTOM. AND TRACKS Laid ON WOODEN
STRINGERS AND POSTS AND PLANKED OVER AT SIDES.

U - 12" WALLS PILASTERED TO 16" AT TRUSSES.
D - 20' BACK DIVISION WALL WITH NUMEROUS OPENINGS HAVING SINGLE NON-STANDARD DOORS
C - METAL ROOF ON 7/8" WOODEN SHEATHING SUPPORTED BY METAL TRUSSES SET ON METAL POSTS BRACED INTO WALLS
D - WOODEN ROOF LANTERN
E - EARTH FLOORS
F - TRANSFER TABLE
