**Risk:** Car House, Repair and Paint Shop.

**Location:** Merritt and Fourth Sts., Columbus, Ohio.

**Owner and Occupant;** The Columbus Railway & Light Co.

## MERRITT ST. CAR BARN AND REPAIR SHOP INDIVIDUAL REPORT NO. 9.

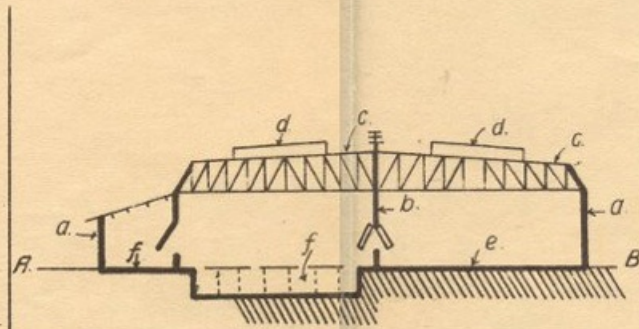
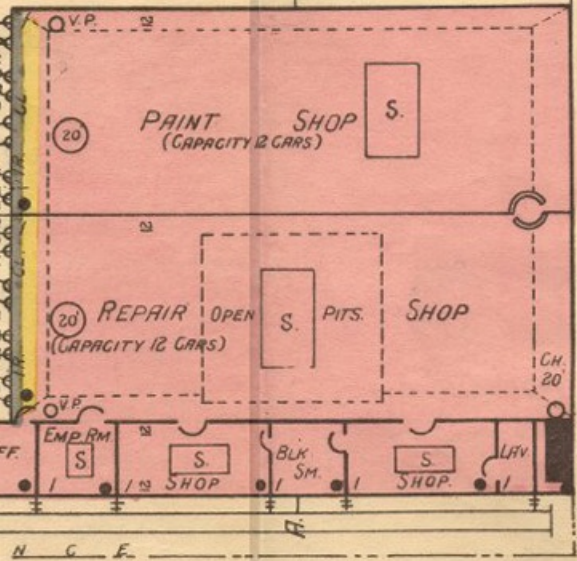
- a - 12" BRICK WALLS WITH BUTTRESSES 15 FEET BETWEEN CENTERS
- b - 12" DIVISION WALL WITH DOUBLE STANDARD FIRE DOORS AT OPENING AND 18" PARAPETS, BUT WITH FRAME END COMMUNICATING BETWEEN SECTIONS.
- c - COMPOSITION TAR AND GRAVEL ROOF ON  $\frac{1}{8}$ " WOODEN SHEATHING WITH WOODEN RAFTERS AND TRUSSES SUPPORTING.
- d - WIRED GLASS SKYLIGHT WITH METAL FRAMES AND METAL COVERED ROOF HOUSE.
- e - CONCRETE FLOOR.
- f - COMMUNICATING PITS WITH CONCRETE BOTTOMS AND SIDES, AND WITH TRACKS ON WOODEN STRINGERS, AND POSTS PLANKED OVER BETWEEN.
