INTERSTATE COMMERCE COMMISSION

REPORT OF THE DIRECTOR OF THE BUREAU OF SAFETY CONCERNING AN  
ACCIDENT ON THE NEW YORK CENTRAL RAILROAD AT KILE, OHIO,  
ON FEBRUARY 7, 1935.

March 25, 1935.

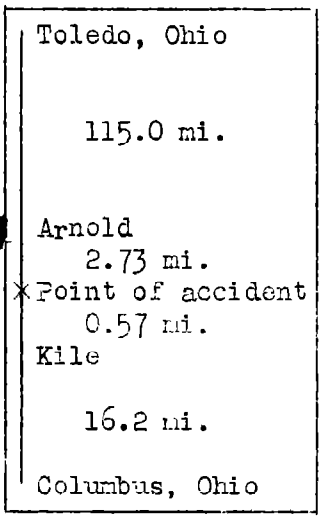
Inv. No. 1965  
 New York Central R.R.  
 Kile, Ohio  
 Feb. 7, 1935

\* Point of accident
