RAILROAD ACCIDENT INVESTIGATION

Report No. 3860

THE PENNSYLVANIA RAILROAD COMPANY

AUGUST 13, 1959

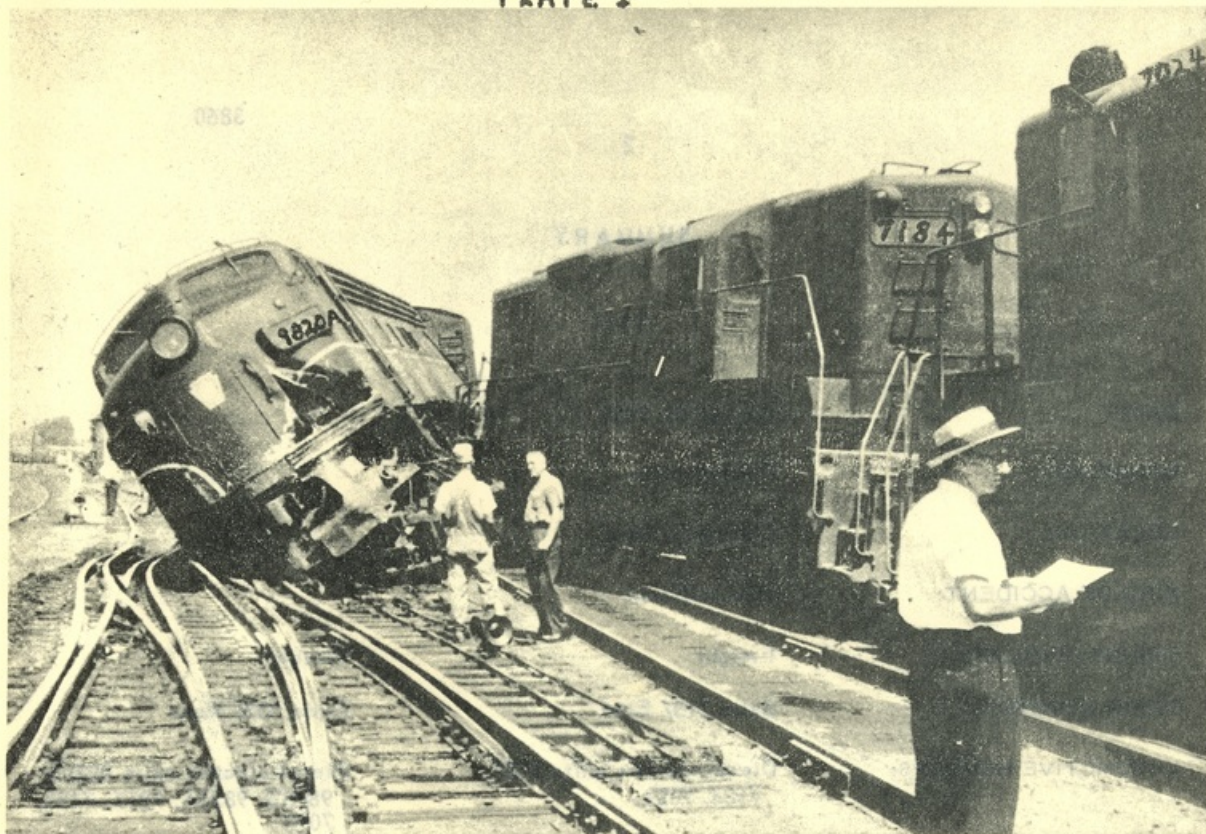
PLATE 1

EASTWARD VIEW

The 1st and 2nd diesel-electric units and the 30th car of Extra 7157 East were derailed. The 1st and 2nd units were somewhat damaged and the 3rd unit was slightly damaged. The 30th, 31st, and 32nd cars were somewhat damaged.

The derailed diesel-electric units of both trains stopped in positions as shown in PLATES 1 and 2. The engineer, the fireman, and the front brakeman of Extra 7157 East were injured. The engineer of the leading locomotive, the firemen of both locomotives, and the front brakeman of Extra 9820 West were also injured.

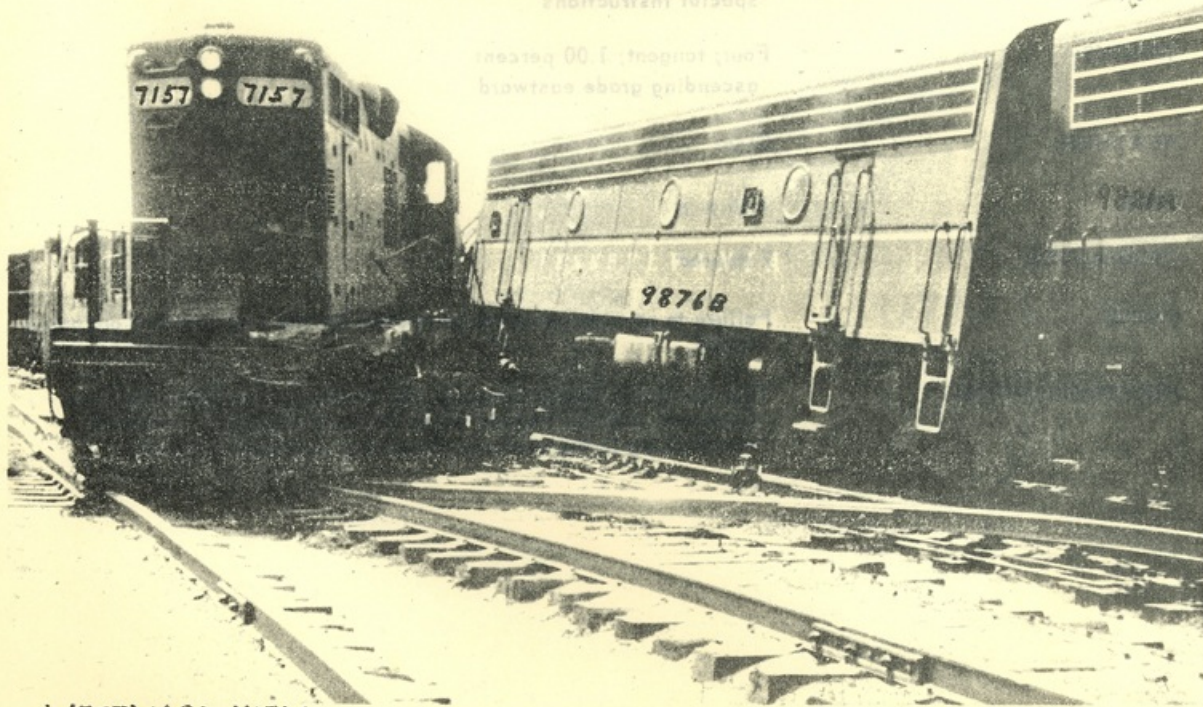
PLATE 2

WESTWARD VIEW

The 1st and 2nd diesel-electric units of Extra 9820 West were derailed. The 1st unit of the first locomotive was somewhat damaged, and the 2nd unit of this locomotive and all units of the second locomotive were slightly damaged.
