150 Workmen Repair Crossing Torn Up in Wreck

(Columbus Dispatch, November 16, 1933)

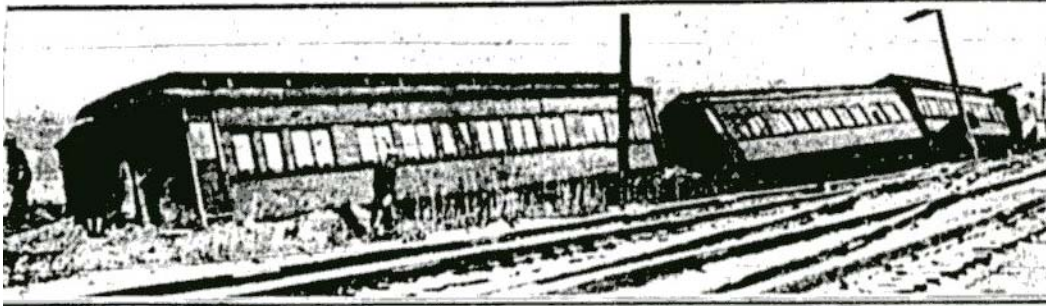
A Big four passenger train is in the ditch at Worthington. The camera is looking west from the Pennsy track. The Big Four track in behind the derailed cars.

Four of the carriers are shown in the top photo, their undercarriages a twisted mass of steel. Of the 130 passengers, only one required hospital treatment.

Sparks flew as steel wheels ploughed across steel rails and seven Pullmans buried their noses in a ditch alongside the Big Four right -of-way south of Worthington early Thursday when the Buffalo-Cincinnati express was derailed.

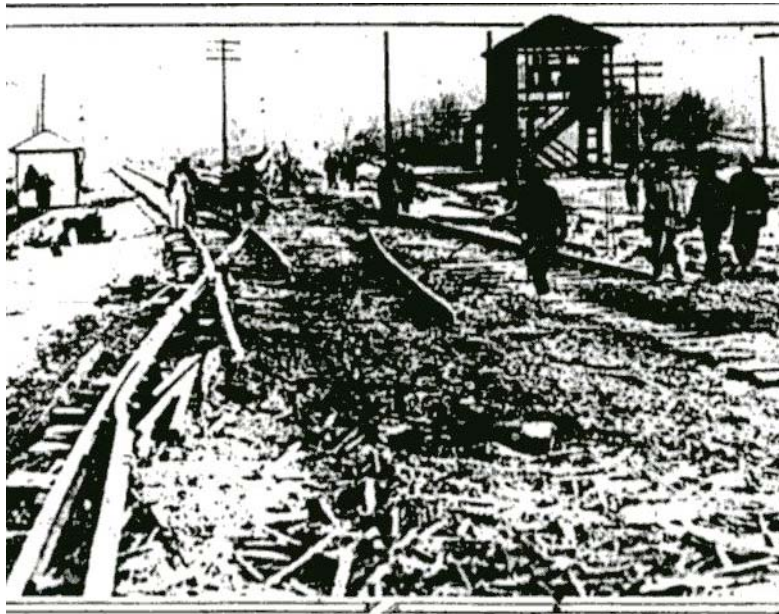
Worthington interlocking tower, where cleanup from a broken rail caused derailment continues. The camera is pointed north looking down the Big four right-of-way. The Pennsy's double tracked Sandusky Branch is crossing the Big Four. There is not much left of the diamond.

Workmen are busy clearing away the crossing of the Big Four and Pennsylvania railroads, where the wreck occurred. A broken rail at the far side of the crossover caused the mishap. The double tracks are on the Pennsylvania line.

One hundred and fifty men were busy removing the debris and constructing a temporary crossing. Railroad service was expected to be resumed on a temporary basis by nightfall.
