General Report No. 1786.

Risk: Car Houses.

Location: Cleveland Ave., Milo, Ohio.

Owner and Occupant: The Columbus Railway & Light Co.

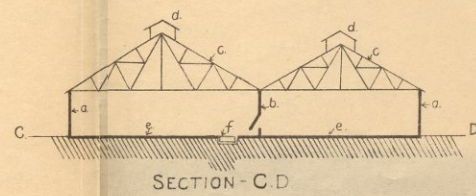
U - 12" WALLS PILASTERED TO 16" AT TRUSSES.
D - 20' BACK DIVISION WALL WITH NUMEROUS OPENINGS HAVING SINGLE NON-STANDARD DOORS
C - METAL ROOF ON 7/8" WOODEN SHEATHING SUPPORTED BY METAL TRUSSES SET ON METAL POSTS BRACED INTO WALLS
D - WOODEN ROOF LANTERN
E - EARTH FLOORS
F - TRANSFER TABLE
