RAILROAD ACCIDENT INVESTIGATION

Report No. 3860

THE PENNSYLVANIA RAILROAD COMPANY

AUGUST 13, 1959

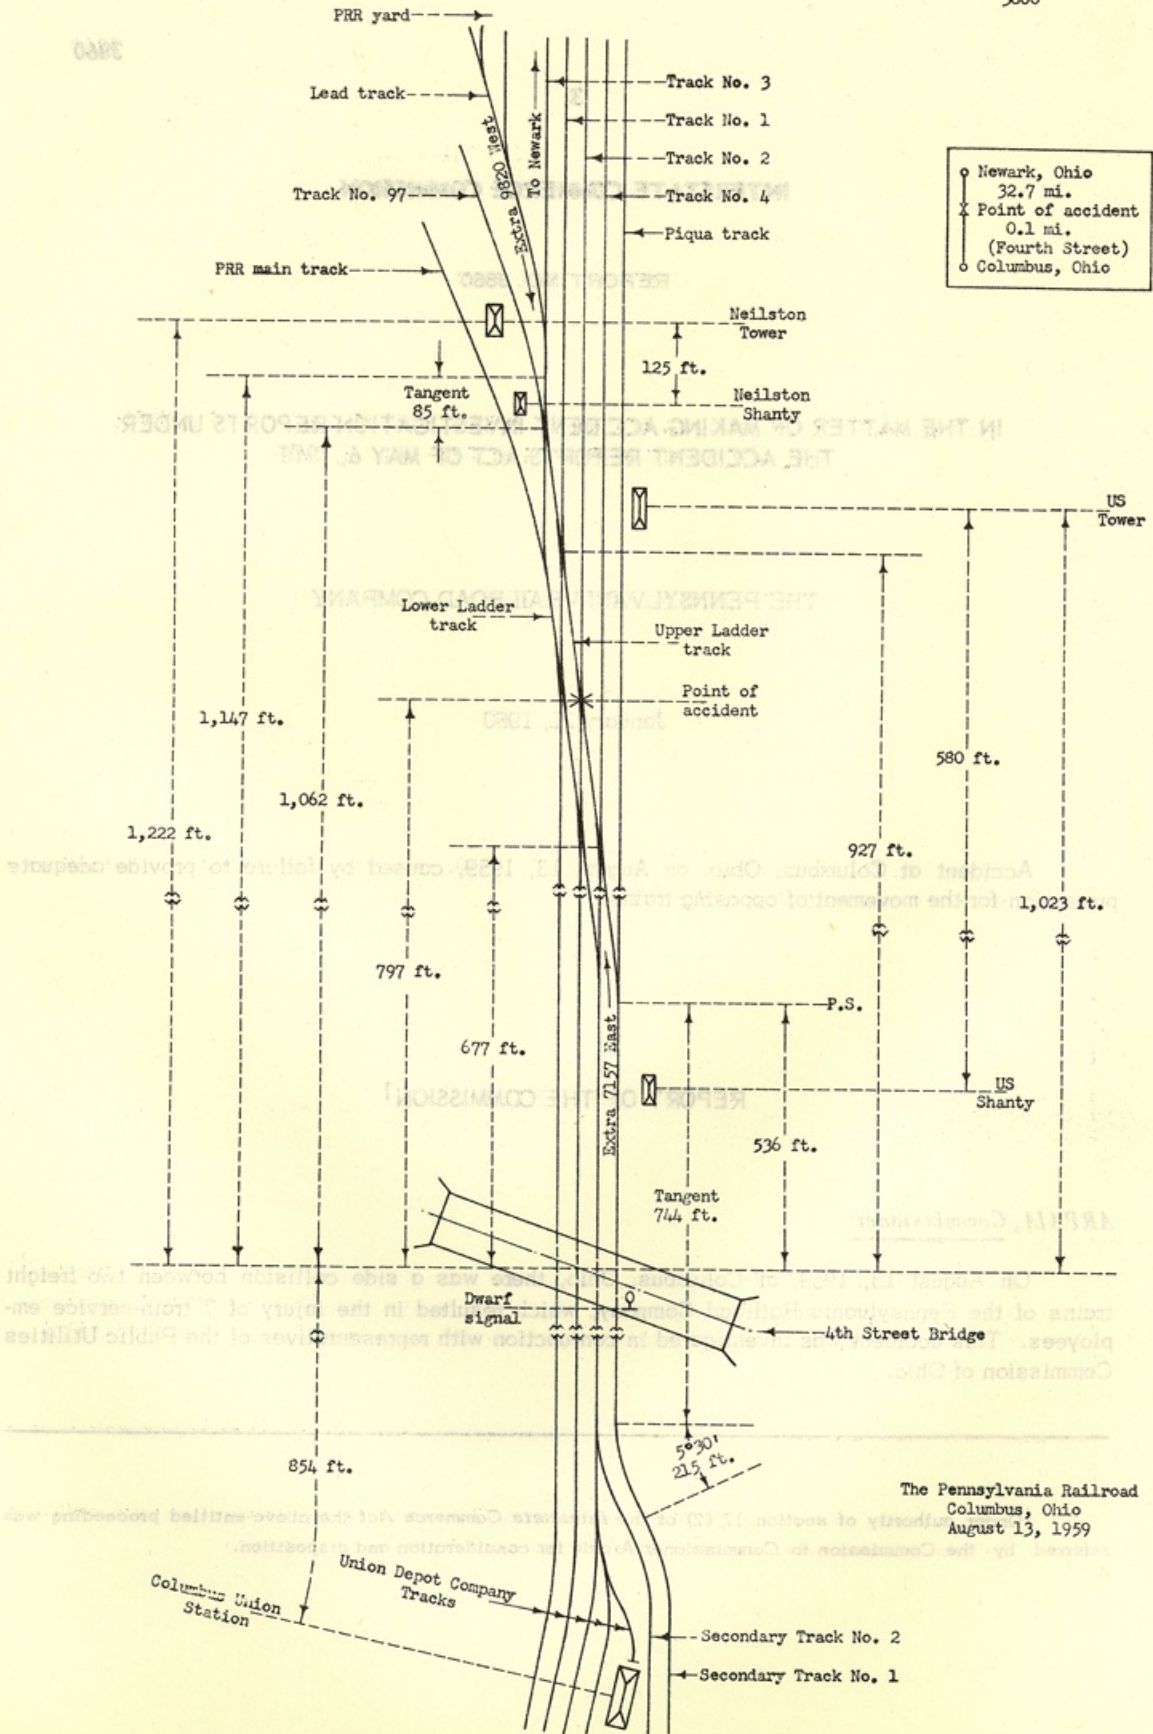
Location of Accident and Method of Operation

This accident occurred on the Columbus and Newark Division which extends between Fourth Street, Columbus, and Newark, Ohio, 32.8 miles, and over which trains of the Pennsylvania (PRR) and the Baltimore and Ohio Railroads are jointly operated. In the vicinity of the point of accident this is a four-track line over which movements are governed by rules of the PRR and timetable special instructions of the Columbus and Newark Division. From north to south the main tracks are designated as tracks Nos. 3, 1, 2, and 4. An auxiliary track, which is designated as the Piqua track, parallels track No. 4 on the south. The station at Columbus is located 854 feet west of Fourth Street, and movements on the station tracks are controlled by the Union Depot Company. In the vicinity of Fourth Street, the west ends of tracks Nos. 1, 2, and 4 are connected to tracks of the Union Depot Company. Two PRR tracks, designated from north to south as Secondary Track No. 2 and Secondary Track No. 1, parallel the Union Depot Company tracks on the south. Secondary Track No. 2 is connected to track No. 4 at a point 103 feet east of Fourth Street, and westward from a point 280 feet east of Fourth Street, Secondary Track No. 1 is a continuation of the Piqua track. Two PRR tracks diverge to the northeast from the four-track line. The track on the east is designated as track No. 97. It is connected by a track designated as the Upper Ladder track, to tracks Nos. 3, 1, 2, and 4, and the Piqua track at points, respectively, 1,062 feet, 927 feet, 797 feet, 677 feet, and 536 feet east of Fourth Street. The track on the west is connected by another ladder track, which is designated as the Lower Ladder track, to tracks Nos. 3, 1, 2, and 4. A PRR yard is located north of the four-track line and east of the ladder tracks. The lead track at the west end of this yard is connected to track No. 3 at a point 1,147 feet east of Fourth Street.
