REPORT NO. 1957

Railroad: Cleveland, Cincinnati, Chicago & St. Louis  
Date: December 23, 1934  
Location: Paget, Ohio  
Kind of accident: Side collision  
Trains involved: 2 passenger  
Casualties: 3 employees killed; 32 persons injured  
Summary of facts: Engineman apparently experienced temporary lapse from consciousness immediately prior to accident.  
Cause: Failure of engineman properly to observe and obey stop indication of a combination train-order and manual-block signal at junction of two main lines.

REPORT OF THE DIRECTOR OF THE BUREAU OF SAFETY CONCERNING  
AN ACCIDENT ON THE CLEVELAND, CINCINNATI, CHICAGO &  
ST. LOUIS RAILWAY AT PAGET, OHIO, ON DECEMBER 23, 1934.

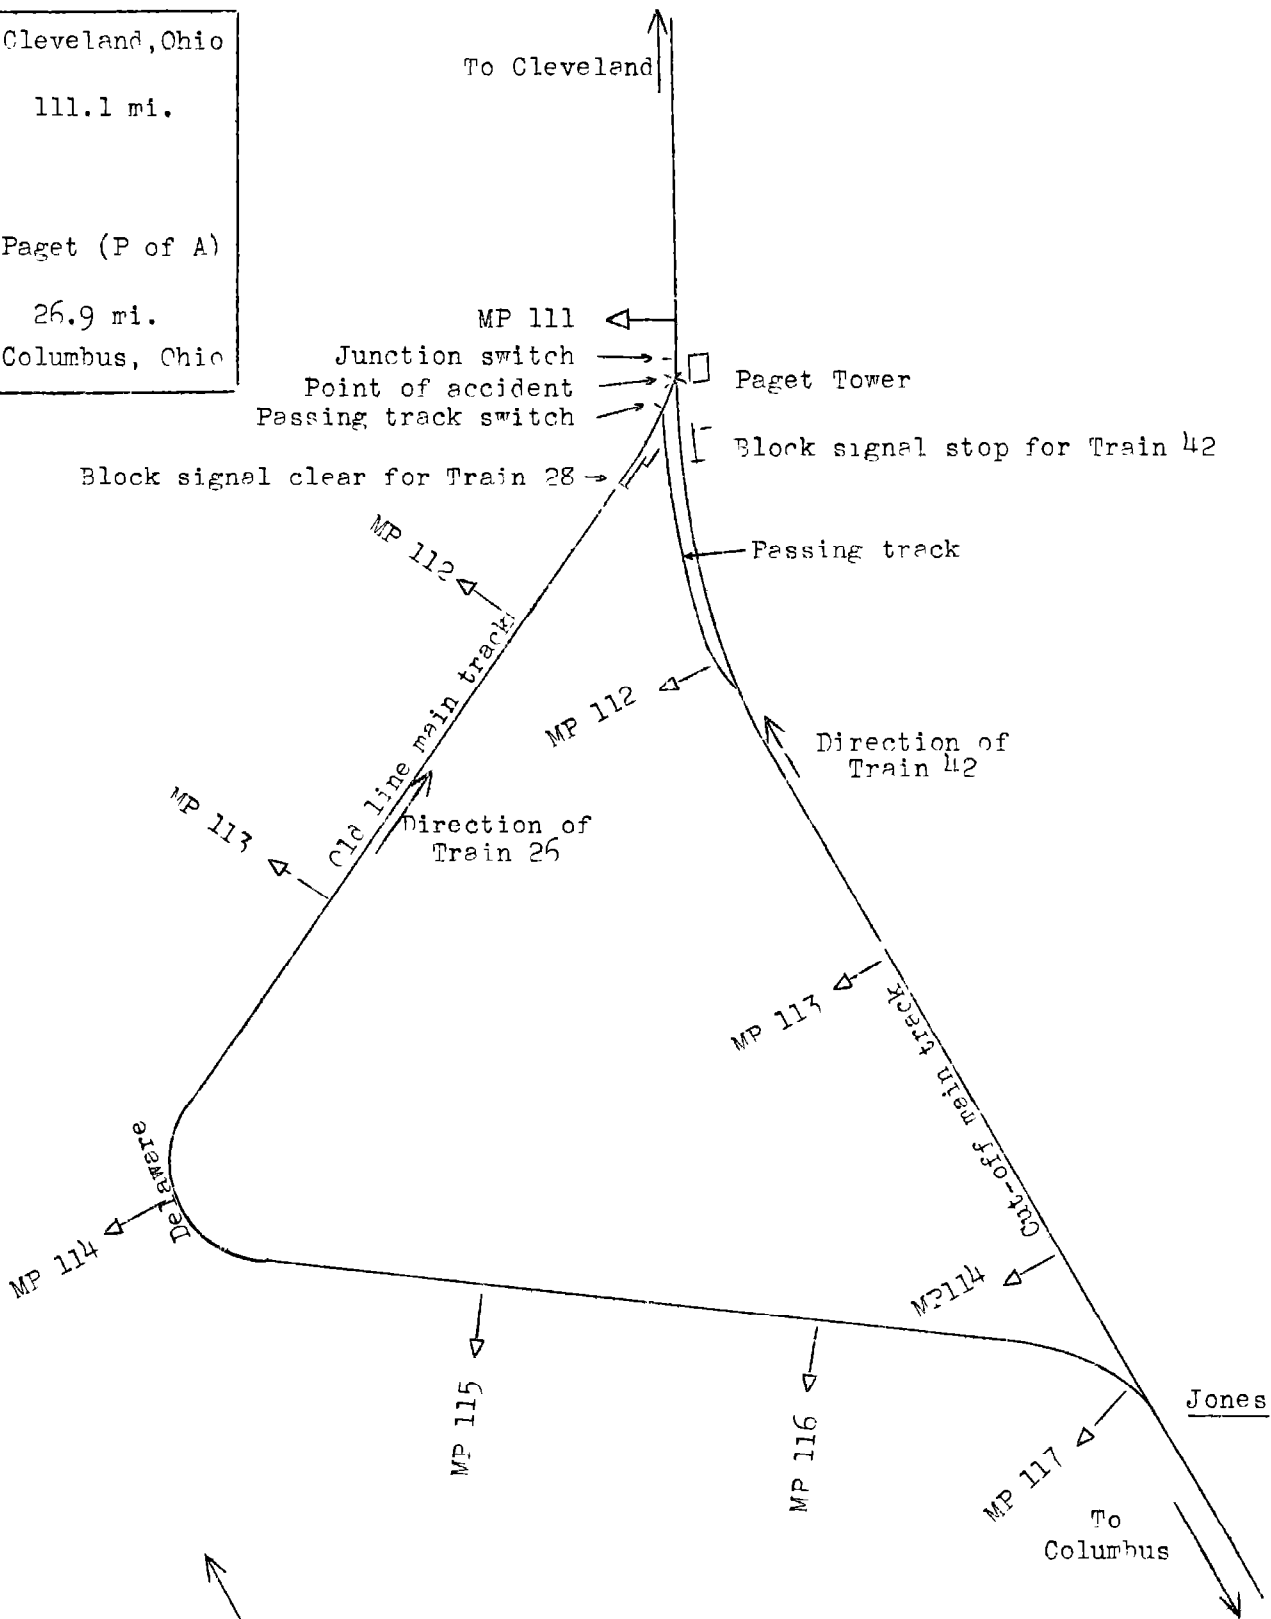
Inv. No. 1957  
 C.C.C. & St. L. Rv.  
 Paget, Ohio  
 Dec. 23, 1934

o Cleveland, Ohio
111.1 mi.
* Paget (P of A)
26.9 mi.
o Columbus, Ohio

Paget cabin, which contains levers for operating signals at the junction, is located south of and opposite the junction switch, while the switch stand is on the north side of the track. At a point 220 feet west of the junction switch a passing-track switch leads off the old main line and then the passing track parallels the cut-off on the north for a distance of 4,563 feet; the stand
