REPORT OF THE DIRECTOR  
BUREAU OF SAFETY

ACCIDENT ON THE  
PENNSYLVANIA RAILROAD

CUYAHOGA FALLS, OHIO

INVESTIGATION NO. 2440

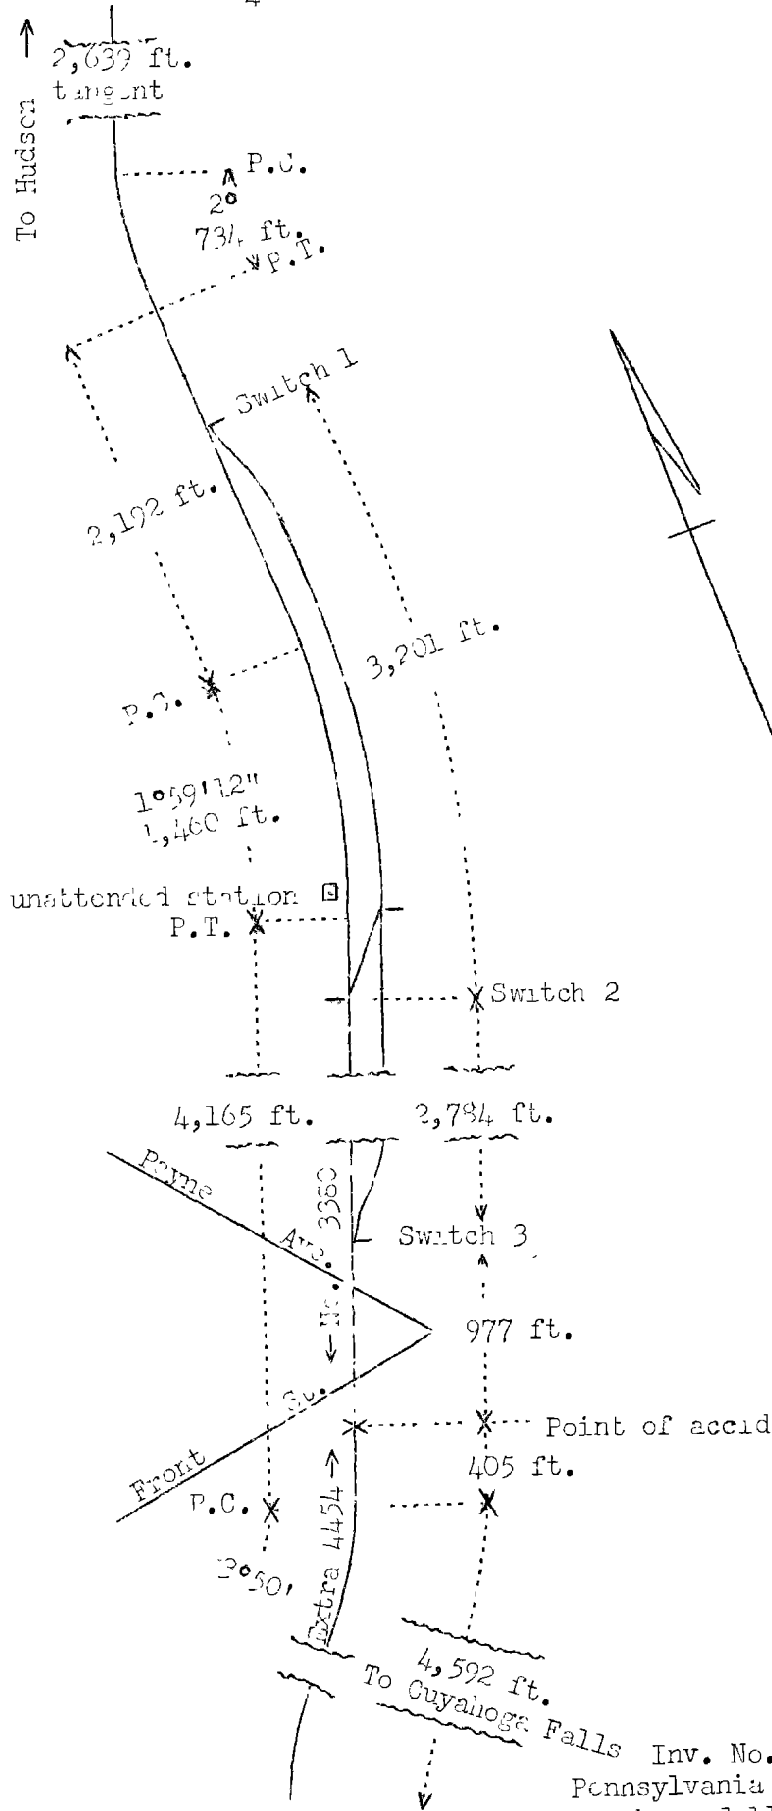
| o | Hudson, Ohio |
| | 6.3 mi. |
| o | Silver Lake |
| | 4,165 ft. |
| x | Point of accident |
| | 4,592 ft. |

A siding 5,985 feet in length and designated as Silver Lake is north of the point of accident and parallels the main track on the east. The switches are numbered progressively from north to south; the most northerly is designated as switch one, the intermediate, switch two, and the most southerly, switch three; these switches are, respectively, 2.37, 1.58, and 1.05 miles north of the station at Cuyahoga Falls. The accident occurred at a point 977 feet south of switch three. Payne Avenue and Front Street cross the main track diagonally at points, respectively, 677 and 872 feet south of switch three.

An unattended block-station sign is located at a point 2,934 feet south of switch one, 267 feet north of switch two, and 3,050
