**Individual Report** No. 13.

**Risk:** Power House and Storage and Storage Battery House.

**Location:** Central Ave. and W. Mound St., Columbus, Ohio.

**Owner and Occupant:** The Columbus Railway & Light Co.

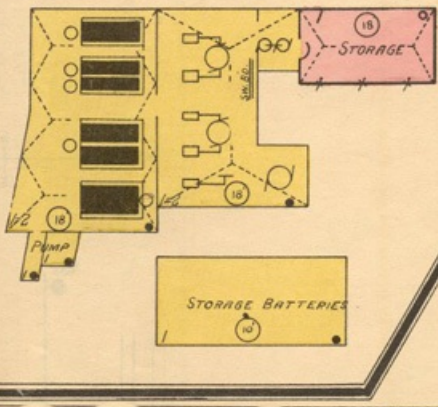
CENTRAL AVE. POWER HO.  
INDIVIDUAL REPORT NO. 13

**Power House & Storage:** A 1 story frame power house 18 feet to the eaves and a 1 story brick storage house of the same height adjoining and communicating, the power house being built on a hill side the engine room being higher than the boiler room. **Area** is 10,500 square feet. **Roof** is tarred paper covered on light wooden sheathing and wooden rafters and posts. **Floor** in the boiler room is of earth and in the engine room and storage house of plank on joists and considerably oil soaked. There is a frame partition between the engine room and the boiler room and a pipe basement under the engine room.

**Storage Battery House:** A 1 story frame building 10 feet to the eaves. **Roof** is composition tarred paper covered on wooden sheathing with wooden rafters and posts supporting. **Floor** is of earth.

There are no outside exposures but the storage battery house and the power house are but 10 feet apart.
